LAS BRISAS LAKE DAM

FRANKLIN COUNTY, MISSOURI

MO 30541

**PHASE 1 INSPECTION REPORT
NATIONAL DAM SAFETY INSPECTION**

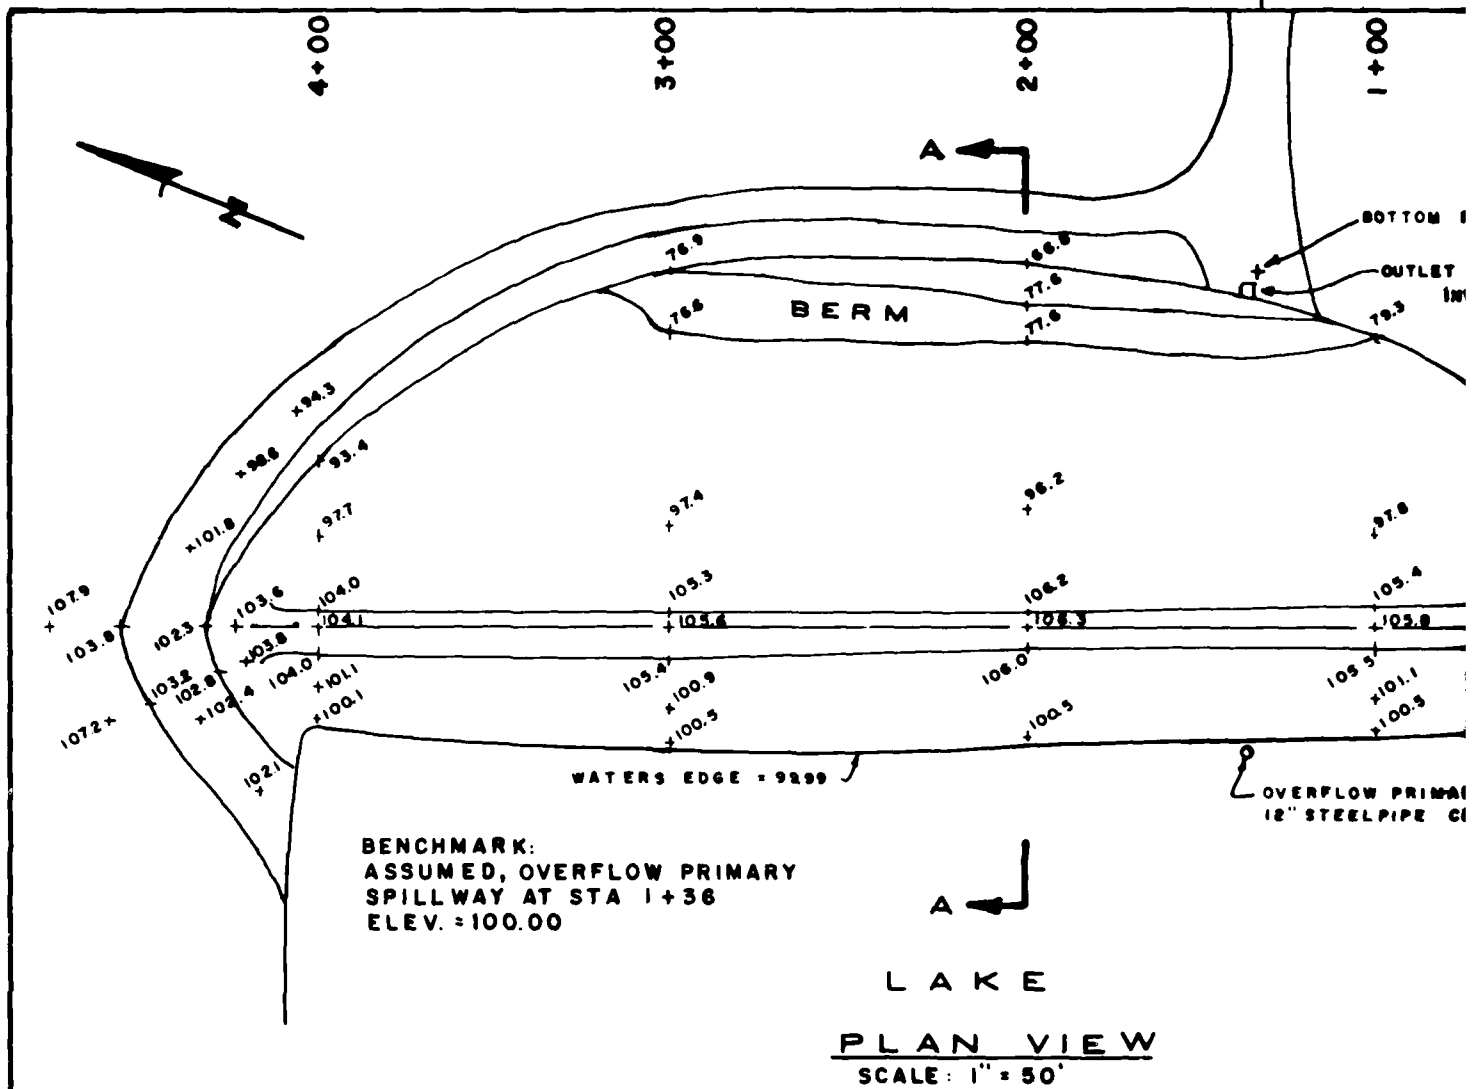
SHEET 3 APPENDIX A

All elevations are consistent with an assumed elevation of 100.00 for the crest of the primary spillway at Station 1+36 (see Sheet 3, Appendix A).

- (1) Location: Station 1+36 (See Sheet 3 of Appendix A)
- (2) Type: 18 in. Diameter Steel Pipe Drop Inlet with 12 in. Diameter Steel Pipe Through Dam

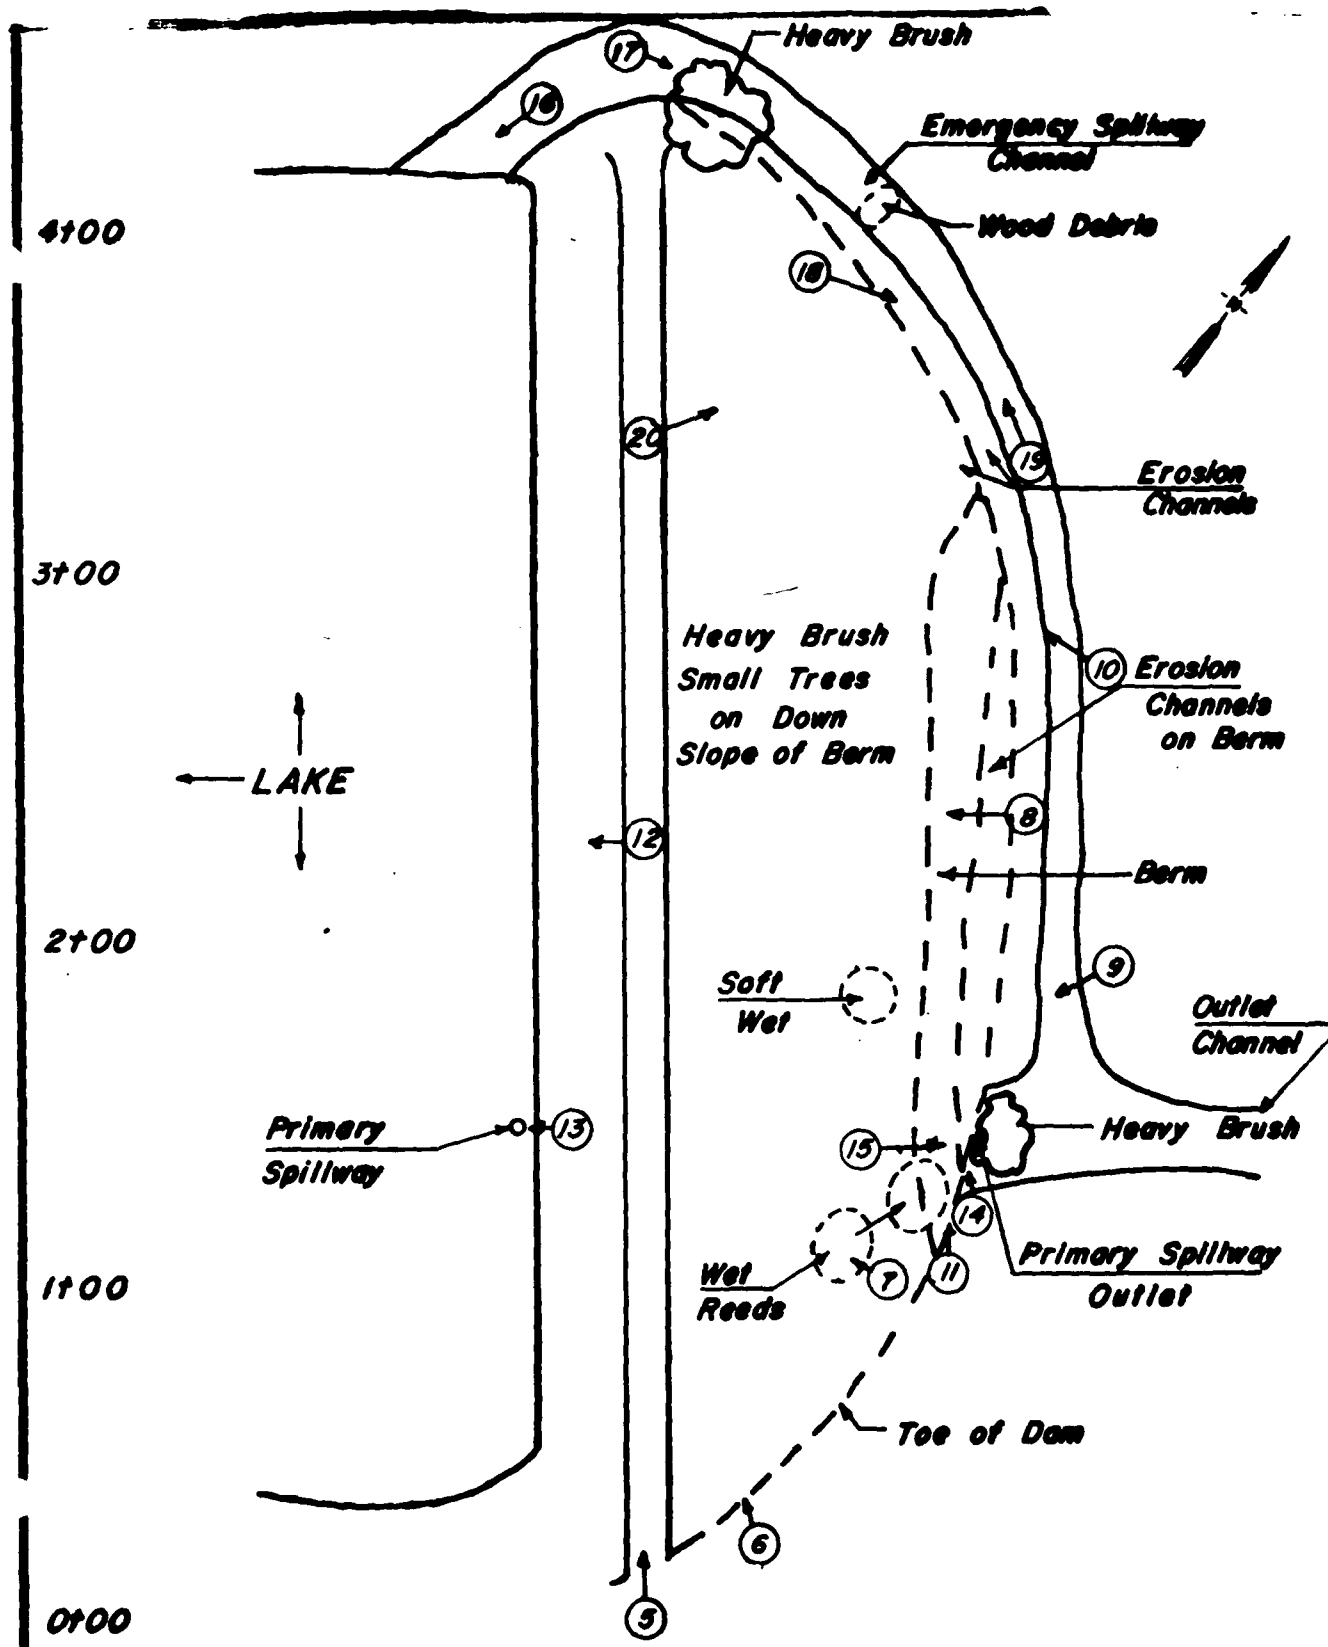
Sheet 2 Appendix D

Several apparent seepage areas were noted on the downstream face above the berm level between Stations 1+00 and 2+00 and between elevations 80 and 90. This seepage is manifested by wet, soft areas growing cattails and reeds (See Sheet 4 of Appendix A and Photo 7). No obvious flows were evident, so that an estimate of seepage quantity was not possible.

- (5) The seepage areas noted on the downstream face should be investigated by an engineer experienced in the design and construction of dams. Remedial measures may be required. As a minimum, these areas should be inspected periodically in an effort to detect an increase in the quantity of seepage or any indication that soil particles are being carried by the water. In this event, an engineer should be contacted immediately.
